# A 1-year follow-up case report of a biomimetic no post/no crown fiber-reinforced restoration of a structurally compromised tooth

**Abstract—** Treatment of structurally compromised endodontically treated teeth (ETT) is still a controversial topic faced daily in clinical practice. A correct diagnosis and treatment planning is mandatory to accomplish success and survival of the restoration, but most importantly, to stop the cycle of death of the tooth. This 1-year follow-up case report presents a no post/no crown fiber-reinforced restoration of a structurally compromised endodontically treated tooth. A 65-year-old female sought treatment for her upper left first premolar that had had endodontic treatment and an old MOD amalgam filling from a long time ago before it broke down. The buccal cusp was fractured, leaving less than 50% of the coronal tooth structure. While a conventional approach would require a cast metal or fiber post and a full-coverage crown, a biomimetic approach was chosen for this case. Therefore, a biobase was used for dentin replacement, and a ceramic restoration replaced the enamel. The biobase was reinforced with polyethylene fiber at its base to reduce the st

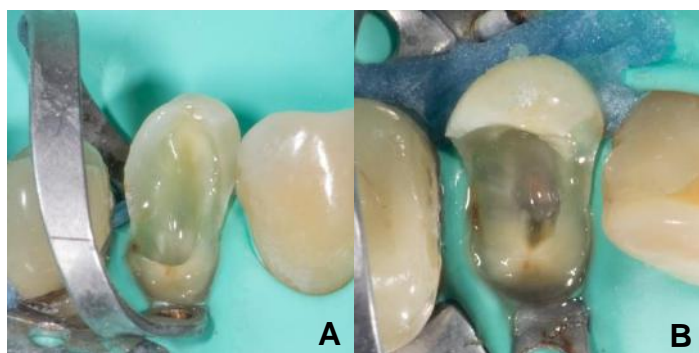
Fig.6. Build-up with short fiber-reinforced composite (Ever X, GC). A: Buccal aspect. B: Occlusal aspect.

viscosity resin (Fortify, Bisco) and then applied over a thin layer of non-polymerized universal composite resin (Clearfil AP-X, Kuraray). Light-polymerization was performed for 20 seconds. The dentin core was created using 2-mm increments of a short fiber-reinforced composite resin (everX Posterior, GC) (figure 6). Light-polymerization was then performed for 10 seconds after each increment. This composite was covered with a universal composite resin (Clearfil AP-X, Kuraray) and light-cured for 20 seconds (Figure 7). The tooth was covered with glycerin gel, and a final light polymerization was carried out for 60 seconds. Preparation was performed for a  $\frac{3}{4}$  partial crown (vonlay) with a chamfer-type finishing line on the buccal and proximal margins of the tooth and a cusp reduction of 1.5 mm on the palatal cusp with a bevel of 1.5 mm width. The impression for the laboratory procedures was made with polyvinyl siloxane (President, Coltene). The  $\frac{3}{4}$  partial crown (vonlay) was made of lithium disilicate according to manufacturer instruction (IPS e.max Press, Ivoclar) (Figure 8 and 9).

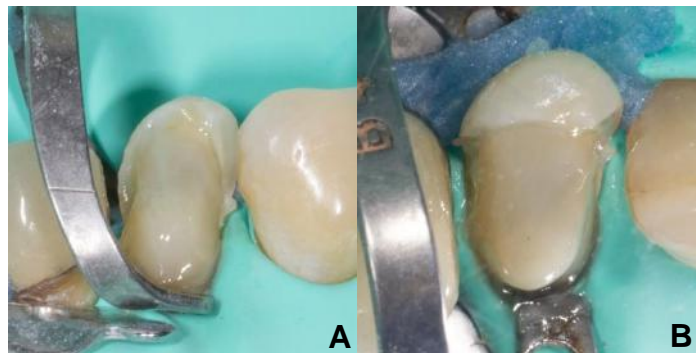
Fig.4. Polymerized self-etch adhesive and resin coated. A: Buccal aspect. B: Occlusal aspect.

Root canal retreatment followed by dentin reconstruction(build-up) and enamel replacement with a ceramic partial crown was planned. The treatment plan was discussed with the patient, and informed consent was taken. For better access and moisture control, rubber dam isolation of the tooth was performed (Rubber dam; Nictone) (Figure 2). Carious tooth structure was then removed with diamond bur under water spray. The gutta-percha was removed 2 mm into the pulp chamber and then sealed with 1 mm of a light-curing glass ionomer liner (Ionoseal; Voco). Air abrasion with 27 µm aluminum oxide (Danville) was used for 10 seconds at 10 mm and 2 bar with a sandblaster (Microetcher II, Danville) (Figure 3). Dentin hybridization was performed with a two-step self-conditioning adhesive system (Clearfil SE Bond; Kuraray). The acidic primer was actively applied for 20 seconds and gently air-dried for 20 seconds for solvent evaporation. The bond was actively applied for 20 seconds, and the excess was removed with a dry microbrush. Light polymerization was performed for 40 seconds at 1000 mW/cm<sup>2</sup> of irradiance (Valo Grand, standard mode, Ultradent). A resin coating was made with a flowable composite resin (Clearfil AP-X flow, Kuraray)(Figure 4). Light polymerization was then performed again for another 40 seconds. A 2-mm-wide polyethylene fiber was used on top of the resin coating layer (Ribbond-THM, Ribbond), applied between the inner side of the palatal cusp and the floor of the remaining structure (Figure 5). The polyethylene fiber was moistened with a light-cured low
